MIPS R4400PC/SC Errata, Processor Revision 2.0

February 9, 1994

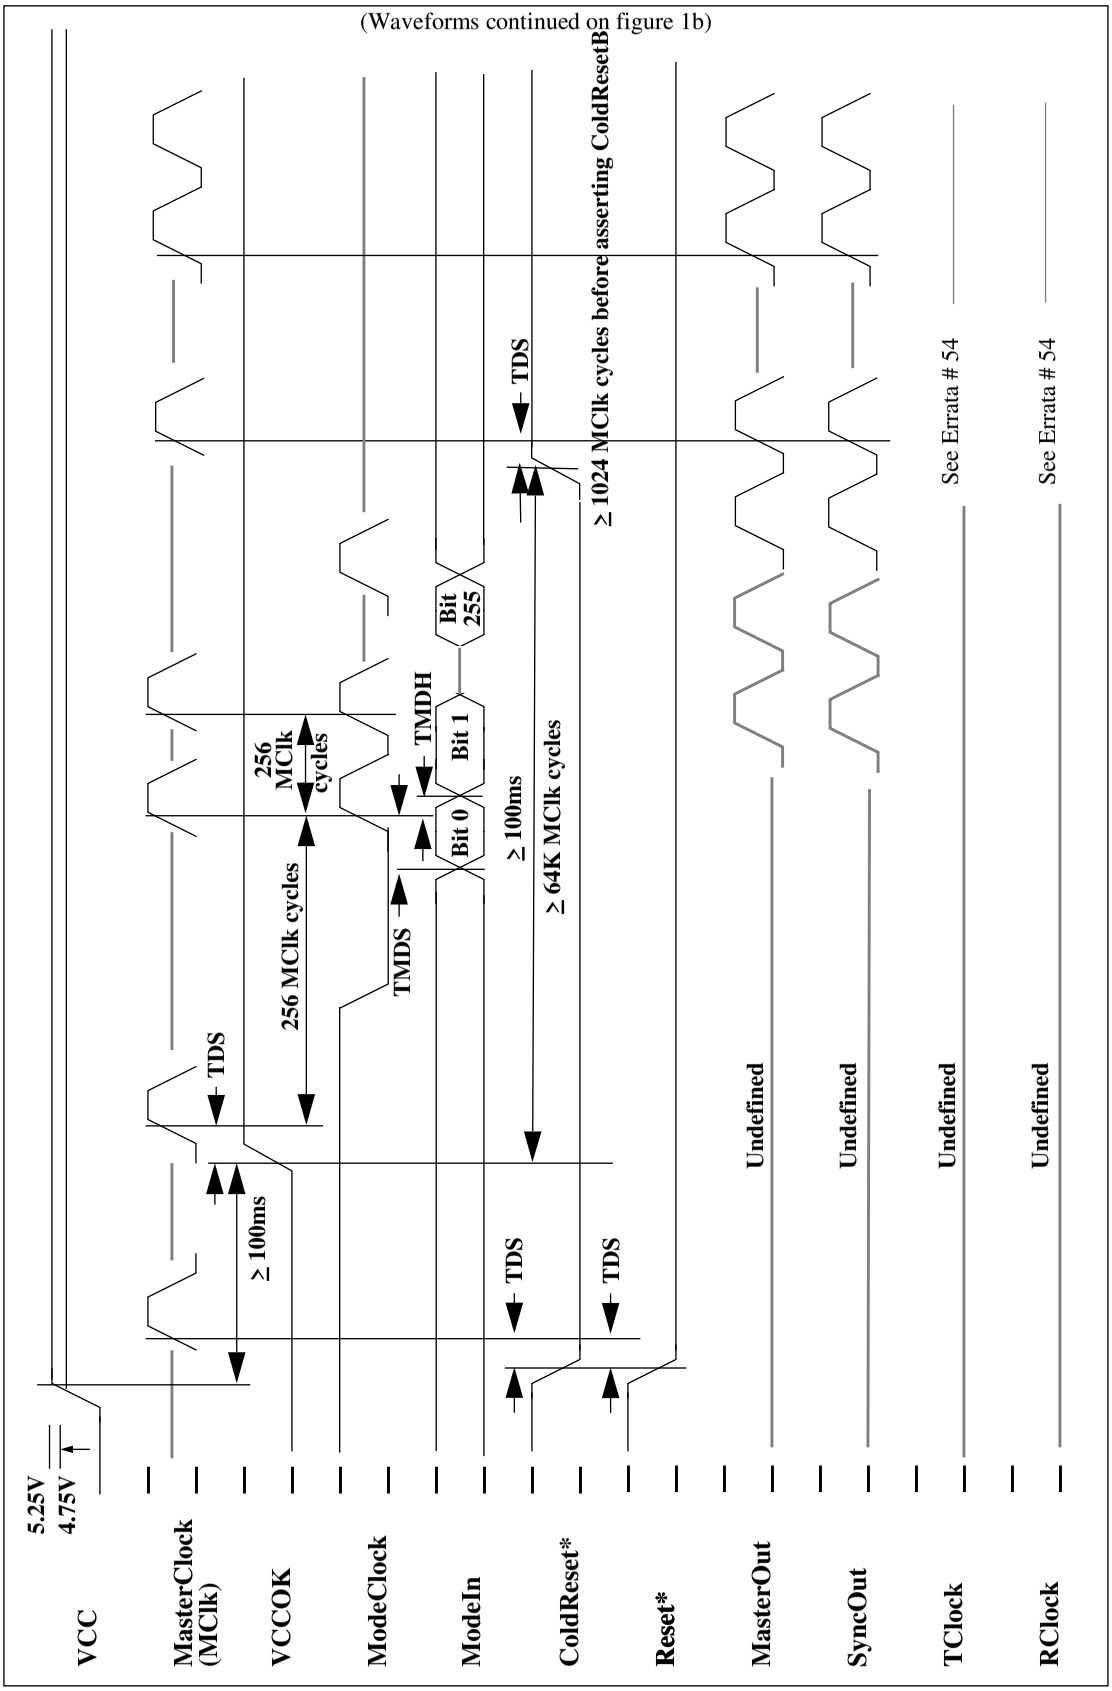
Figure 1a: Power-on Reset or Cold Reset- Workaround for Bug# 16

15. R4400PC, R4400SC: During the power up sequence, the period of TClk and RClk may not be as expected for at least 1024 MasterClock cycles following the de-assertion of ColdResetB. The above bug is true for all system interface divisors. Furthermore, if the system interface divisor other than 2 (i.e. 3,4,6 & 8) is used, TClk and RClk's rising edge may not align to the rising edge of the MasterClock, as specified.

Workaround: Assert a second ColdResetB after at least 1024 MasterClock cycles from the de-assertion of the first ColdResetB. ResetB should remain asserted until at least 64 MasterClock cycles following the de-assertion of the second ColdResetB. TClk and RClk will then be valid 64 MasterClock cycles after the de-assertion of the second ColdResetB and their edge alignment with respect to MasterClock will be as specified. Figure 1a & 1b show the waveforms in more detail. Note that the waveforms in Figure 1b are continuation of the those in figure 1a.
